# Manhole Inspection Summary

## Manhole # S41SS\_023MH

Insp Date: **2/19/07 9:59 AM**

**Location** Address: **2600 KIRK AVE** Cross Street: **FRIENDSHIP ST**

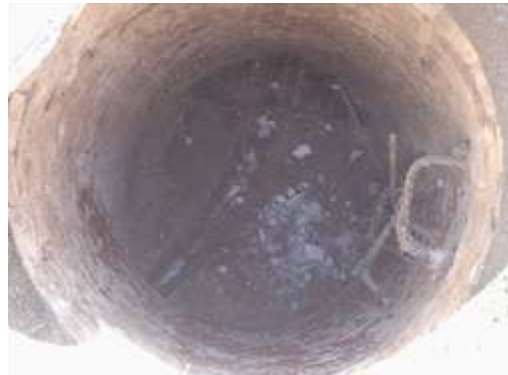
Top View

Frame leaks. Adjustment deterioration and infiltration. Corbel infiltration. Bench debris.

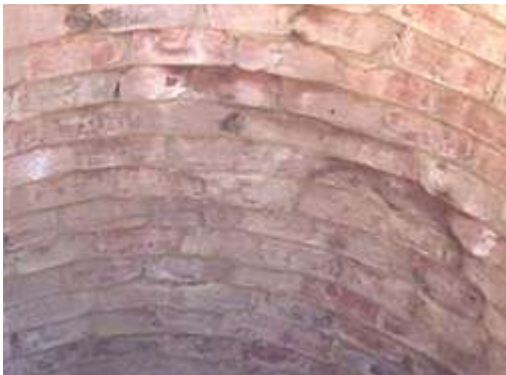
Defect

Adjustment and Corbel infiltration.

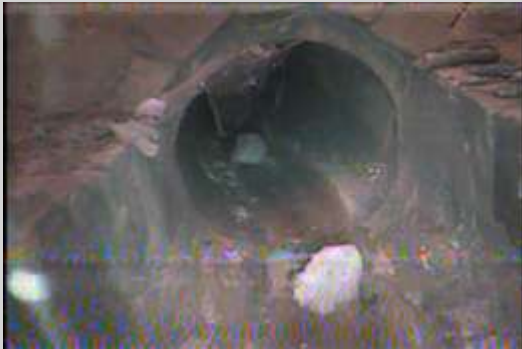
### 8 in. Circular Gravity Sewer Pipe Out @ 12 O'Clock

Infiltration: **None** Pipe Seal Cond: **Sound**

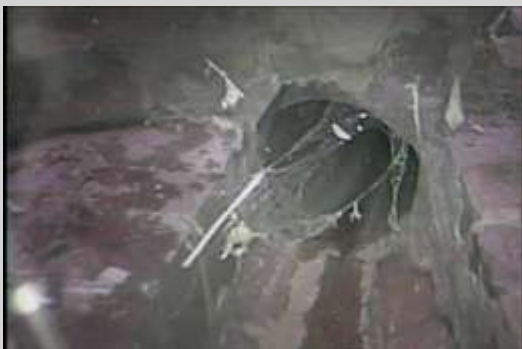
### 8 in. Circular Gravity Sewer Pipe In @ 7 O'Clock

Infiltration: **None** Pipe Seal Cond: **Sound**
